## **Tram Alignment Procedure**

Tram Alignment is the adjustment of the saw arbor and tooling assemblies' alignment in reference to the flow of product. Tram alignment is necessary for the quality of the cuts in the material of the product and longevity of the equipment. Although equipment design may vary, all designs will follow the same guidelines as listed for the 1<sup>st</sup> and 2<sup>nd</sup> Pass Saws.

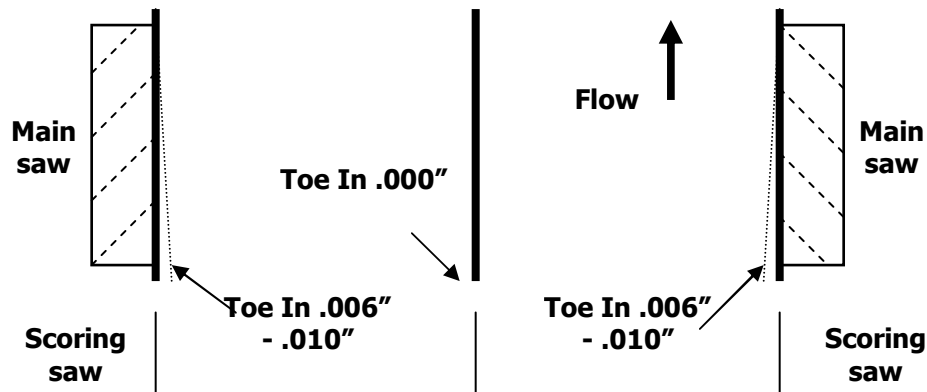
## Illustration "A"

Position of the arbor housing should be as such that the tooling is aligned with the centerline of saw and saw line. The outside saw assemblies may have a "Toe In" of .006" - .010" and splitter saw assemblies (if used) will be parallel of centerline. See illustration "A".

Next, place the dial indicator onto the outside of clean and straight tooling using the magnetic base so that the indicator will read the machined surface of the tramming fixture arm at locations upstream and downstream of the saw assembly when the tooling is rotated.

If adjustments are required, remove the tapered locating pins between arbor housing and the housing mount and loosen the four mounting bolts. Using the Tramming Fixture and the dial indicator, move the arbor housing until above specifications are achieved, tighten mounting bolts, and inspect tram adjustment again to insure the correct position of arbor housing has not changed. Using a #7 tapered reamer, clean and re-align pin seat and install new tapered pins. Pins should seat firmly when tapped into place.
